Investigating an Outbreak of Legionnaires' Disease from Cooling Towers in Surrey, BC

Mark McCabe, Epidemiologist, Fraser Health Contact: mark.mccabe@fraserhealth.ca

NCCEH Environmental Health Seminar Series - Feb 20, 2020

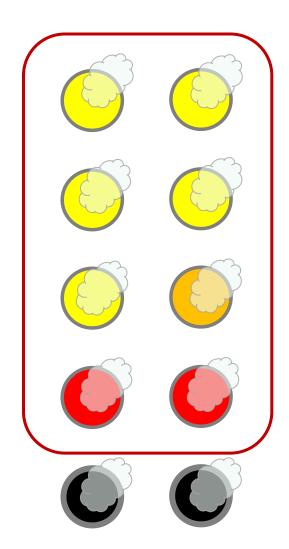
Out of 10 towers tested:

Legionella spp.

5

Legionella pneumophila

1

Legionella pneumophila SG1

2

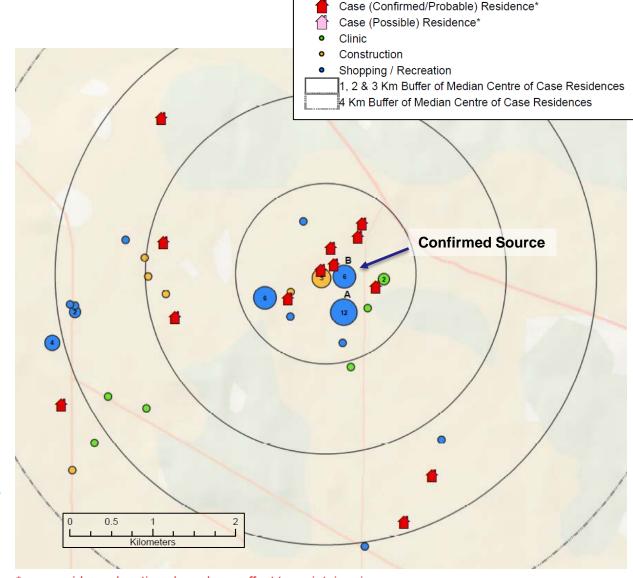
Potential Exposure Locations (# persons visiting)

Of 14 outbreak cases:

- 12 live within 3km of source
 - 7 cases within 1km
- All but one were residents of Surrey
- Nearly half reported visiting the source facility directly, and 86% of cases visited the shopping centre

*case residence locations have been offset to maintain privacy

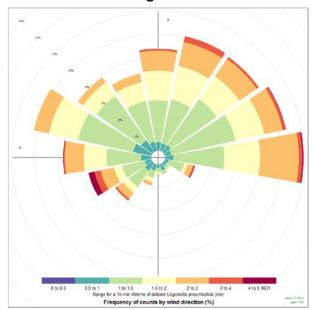
Range Rose

- Range Roses
- Displays the maximum distance and proportion of time that the organism may have been dispersed from a source
- Maximum distance of travel is estimated from:
 - meteorological wind data ('wind roses')
 - Estimated survival of organism in aerosols
 - parameters known to impact survival of the organism (temperature, relative humidity, solar exposure)

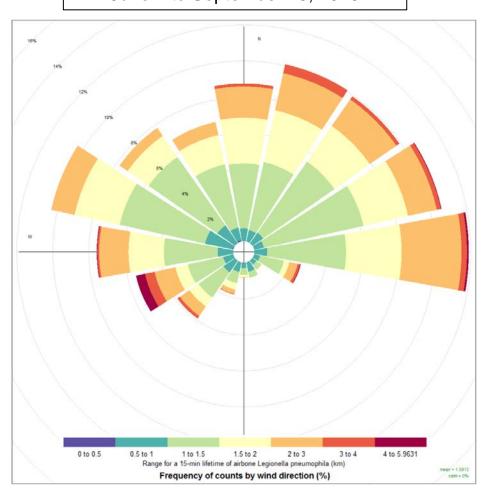
Range Rose from Implicated Source FHA Legionnaires' Disease Outbreak June 1 to September 28, 2019

For ~8% of the time, Lp travelled a maximum of 1.5 to 2 km east from source

- Minimal dispersion of organism in a southerly direction
 - Particularly South to Southeast
- More than half of the time (60%), dispersion was within 2 km in the NE and NW quadrants
- Maximum travel distance was between 1.5 and 1.7 km on average
