Splash Parks: Understanding the Risk and Implementing Better Practice

CIPHI Annual Education Conference

November 6, 2017

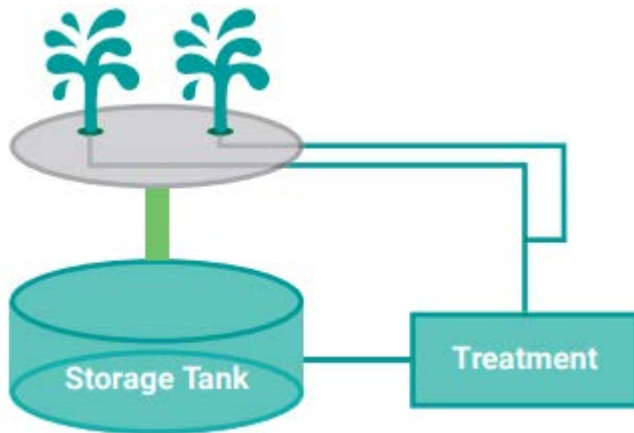
Recirculating

Higher Risk

- Design often not indicated (to public)
- This presentation focused on recirculating splash pads

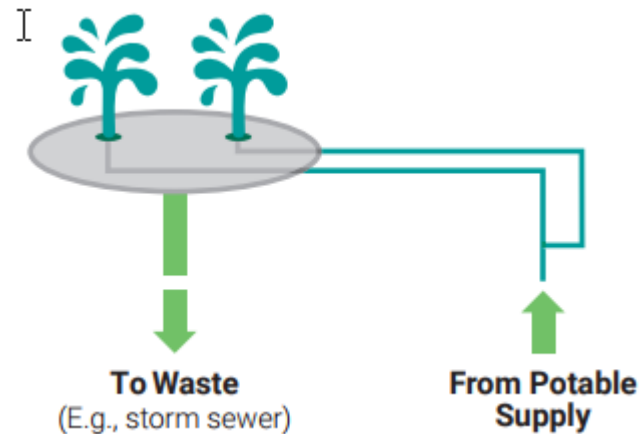
Non-recirculating

Lower Risk

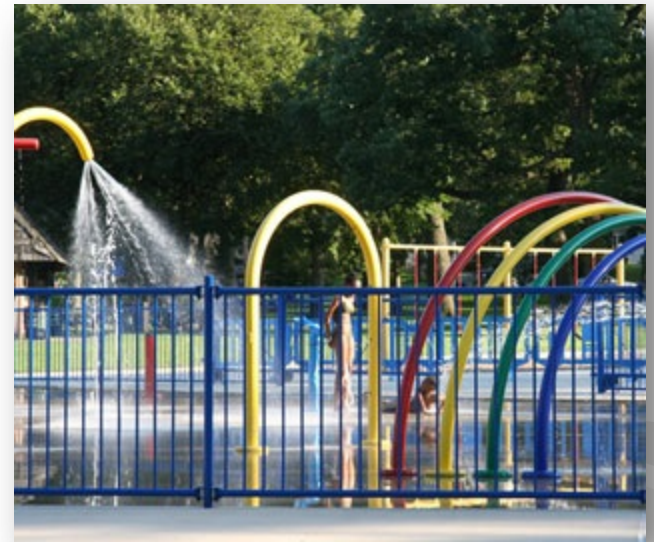
Best Practices: Design

- Proper siting of the pad
- Exclusion of animals
- Adequately sized reservoir
- Provisions for constant recirculation
- Discharge of water when not in use
- Ability to drain the deck directly to waste

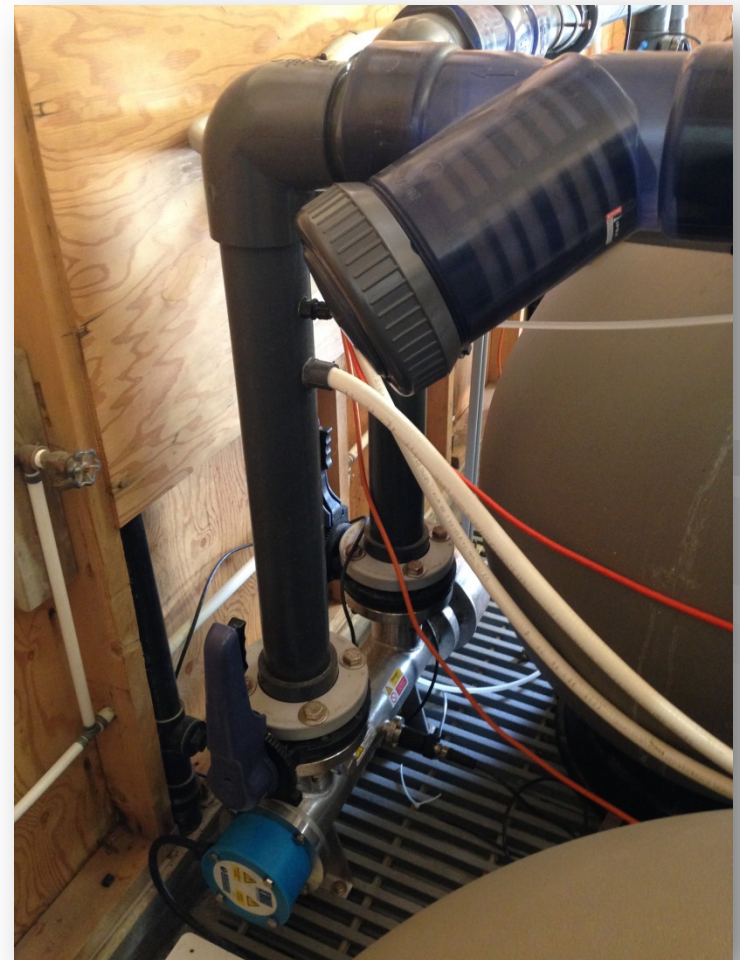
Best Practices: Design

- Chlorination at least 2.0 ppm
- Second form of disinfection (e.g. UV)
- Foggers and misters from potable supply

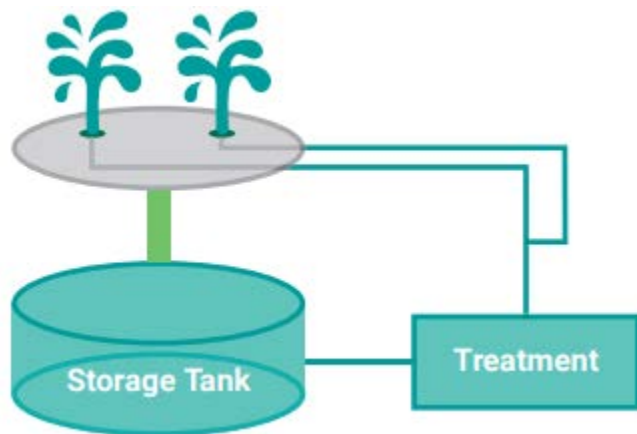
Full Flow Filtration

- Features and filters in series
- 100% of water from filters
- Can be costly

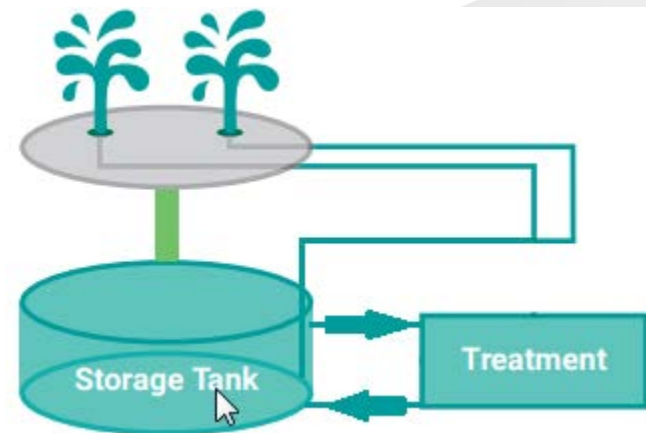
Partial Filtration

- Reservoir treated
- Separate pump feeds features
- Feature pump must not exceed 3X treatment pump
- Turbidity <3NTU

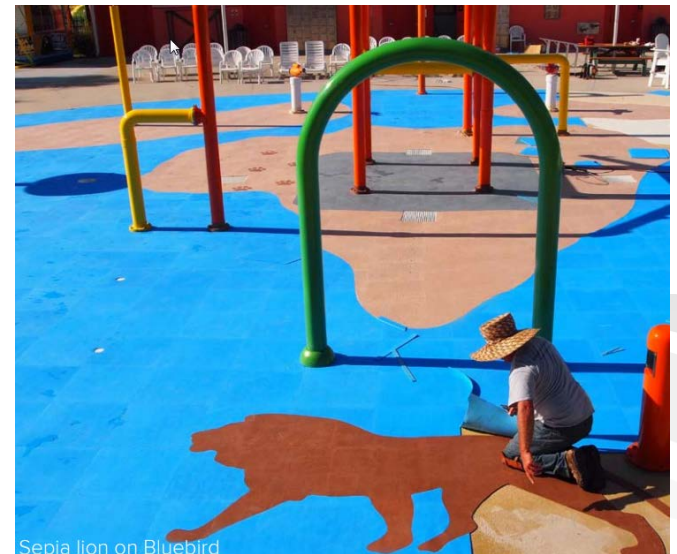
Request sanitizeability assessment of Foam Decking

- Questions about surface
- Question about seams
- Rapid lit search (Summer 2017)
- BCIT student research project (2018)
